# **Fitzroy Gasworks : Overcoming OHH Challenges During Large Scale Site Remediation**

# Overview

Provision of occupational hygiene services for a large-scale soil remediation projects at a former gasworks site in Fitzroy, Victoria, requiring constant management throughout all phases of works.

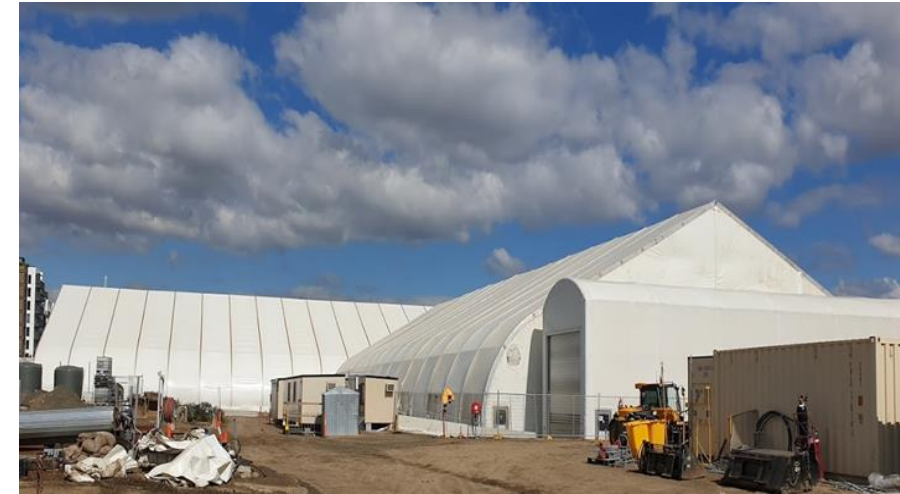
The remediation works are being carried out within 6 separate odour control enclosures (OCE) (i.e. tents under negative pressure with emission control systems). Posing OHH risks and hazards.

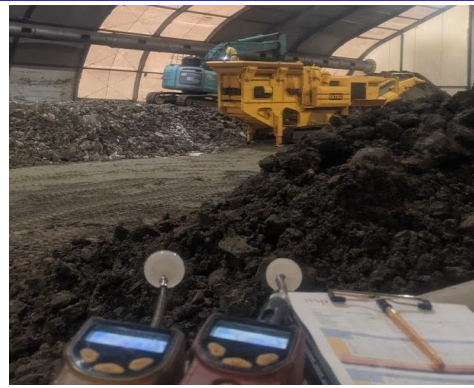
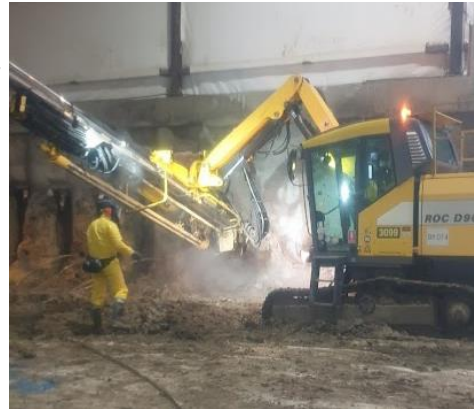
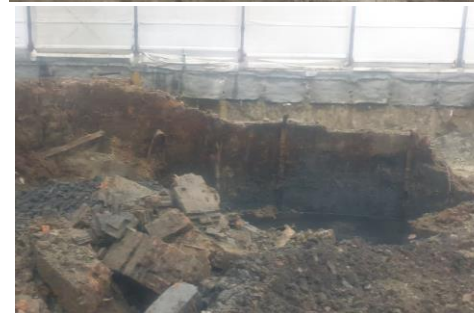
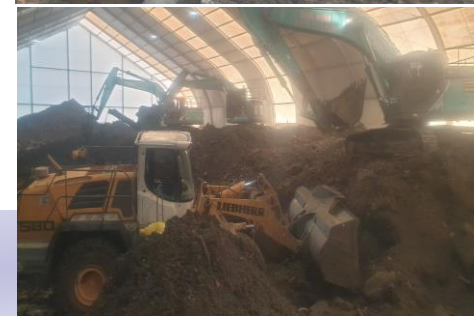
- ❖ Monitoring conditions inside the OCE and adherence to OHHMP.
- ❖ Continuous real-time monitoring for VOC, Benzene, Dust,  $\text{NH}_3$ ,  $\text{NO}_2$ , LEL,  $\text{O}_2$ ,  $\text{CO}_2$ ,  $\text{H}_2\text{S}$ , Temp, RH (%)
- ❖ Personal monitoring of PAH, VOCs, hydrogen cyanide and ammonia, etc.
- ❖ Dust management including RCSD
- ❖ Ongoing heat stress risk assessment process
- ❖ Personal noise monitoring
- ❖ Airborne asbestos fibre monitoring

- ❖ The workers – PPE usage and maintenance – Constantly breaking habits
- ❖ The de-contamination process (shared showers/locker rooms)
- ❖ Constant exceedances leading to evacuations
- ❖ Constant equipment calibrations due to burn out

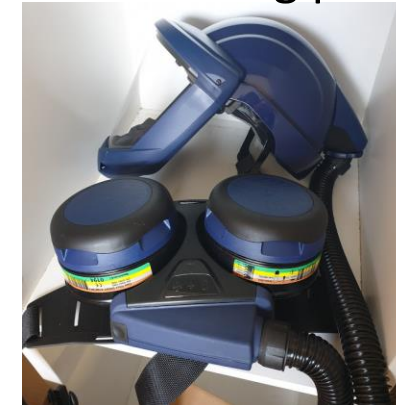
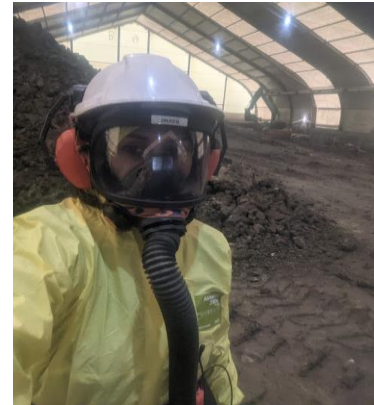
- Chemical coveralls (100% relative humidity)
- Full face, PAPR– flip top and then changed to face fitted PAPR based on real-time data
- No skin exposure with gloves (nitrile/cut resistant), gumboots and hearing protection
